Compressor foundation assessment and repairs key to reducing vibrations

Costly problems can be mitigated by optimizing multiple facets related to the foundation. By **Michael Golla**, Structural Technologies

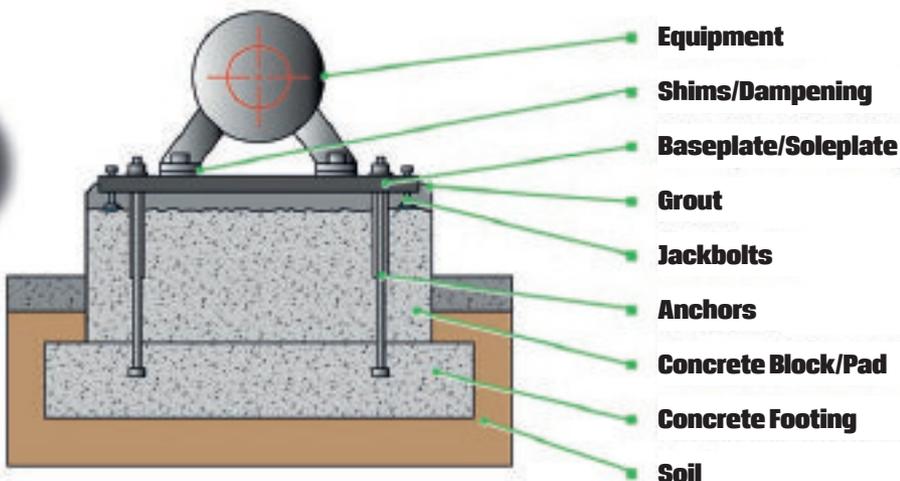
FIGURE 1 Reinforced concrete foundation for compressors

For compressors, a reinforced concrete foundation typically consists of grout, concrete, anchor bolts, jack bolts and soil (see Figure 1). The compressor frame is typically bolted to a baseplate or soleplate attached to the grout and concrete foundation. Jack bolts, chocks or shims might be used at the anchor bolt locations to assist with alignment.

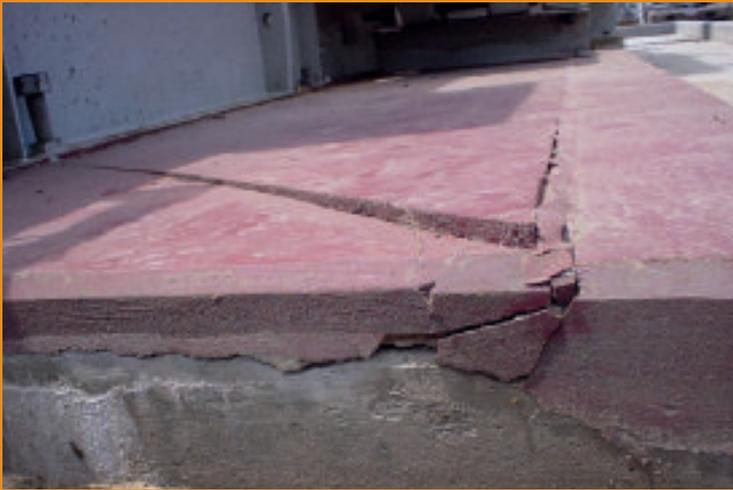
Grout cracking and edge lifting due to excessive grout placement, lack of expansion

the grout design, and grout can separate from the concrete if large grout shoulders are used, causing grout "edge lifting" (see photo #1). Additionally, grout can crack if expansion joints are not used or are not spaced properly. Poor installation can lead to a lack of bonding and voids. Grout should touch the steel above and the concrete below. Steel and concrete surfaces must be prepared properly per guidelines, and grout placement techniques by an experienced contractor must be used to ensure a good bond.

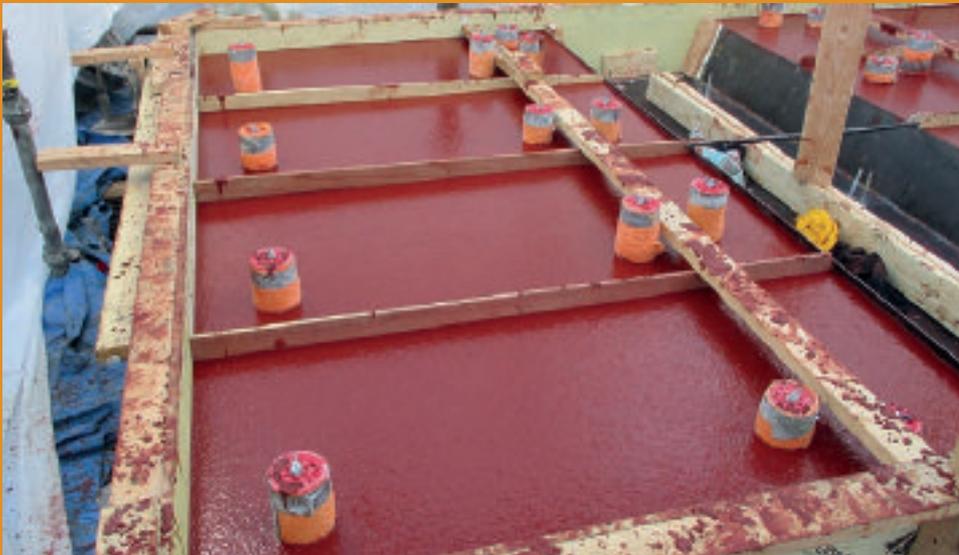
Grout installation with expansion joints and anchor bolt sleeves.

In addition to choosing the proper grout, the grout installation process is also important. There are good guidelines and best practices for formwork, mixing, placement, expansion joints and others. Grout failures are common in the field and include design and installation issues. From a design perspective, point load cracking can occur due to sharp or square edges in

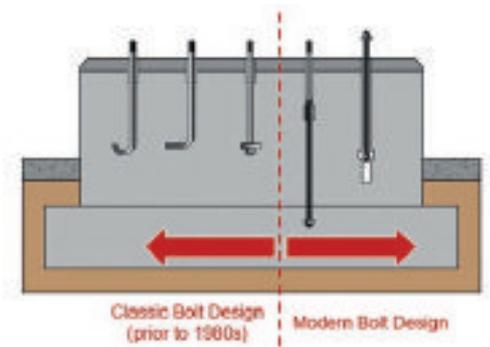
FIGURE 2 Anchor bolt design evolution

Anchor bolts are another critical part of the foundation to resist forces and minimize vibration, and they are just as important as the grout. The grout prevents downward movement and the anchor bolts prevent upward movement. Concrete is strong in compression but weak in tension. Anchor bolts provide the tensile strength. Key considerations include the bolt material and fabrication, the type of termination, tension/torque relationships, allowed stretch, and adequate concrete cover. Many foundations designed prior to the 1980s do not follow today's standards for anchor bolts, potentially causing vibration issues (see Figure 2).

The importance of anchor bolts and termination design has been thoroughly researched in recent years, resulting in new standards for anchor bolt material, thread design and lengths that can also help minimize foundation cracking under stress. For example, "J" and "L" bolt designs, square plates and thin washers used in the past

were not strong enough, resulting in concrete cracking and increased vibration. New designs are much improved. Round plates and plain nuts, instead of square plates and thin washers, help reduce tensile stresses caused by anchor bolts in the concrete. Extra rebar can be installed at the termination point of anchor bolts to provide extra strength and prevent cracking. Additionally, the metallurgy, number, diameter and length of anchor bolts are critical. Undersized anchor bolts were common on older machines. Bolts should now be as long as possible to provide more stretch to increase the clamping force.

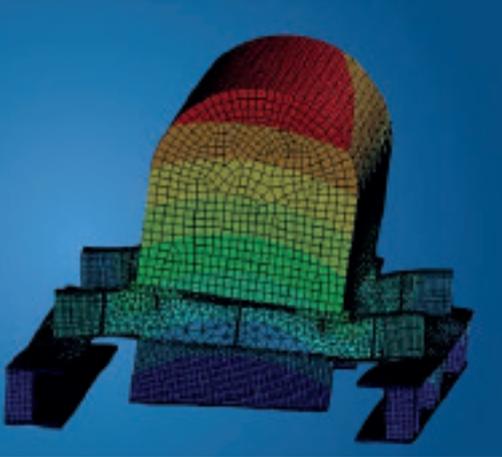
FIGURE 3 ODS example of compressor motor vibration (without animation)

ODS uses sensors to measure vibration at different locations on the foundation system at the compressor operating speed and frequency on a given day. Software is used to provide a 3D animation of the foundation movement (see Figure 3). It might be able to determine if a particular part of the foundation is vibrating excessively, such as a cylinder support pedestal, due to resonance, inadequate design, or deteriorated concrete. It is a proven method for identifying certain types of vibration problems and has been used for many years.

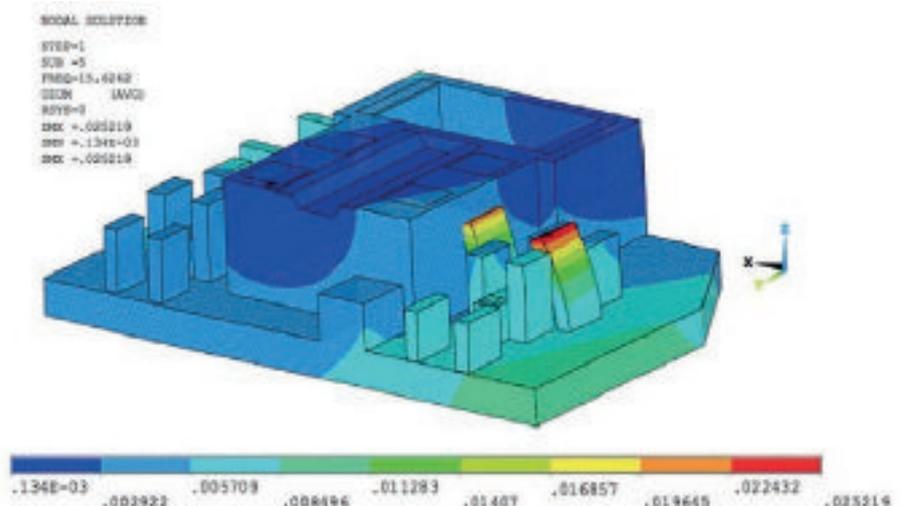
FIGURE 4 FEA results to determine source of foundation vibration

ODS confirmed that two cylinders (one side of compressor concrete block) were moving too much and FEA confirmed that two separate cylinder support piers (not attached to the block) were resonating at compressor operating frequency (see Figure 4) and also contributing to vibration. FEA was then used to redesign the supports to eliminate the resonance. The solution included strengthening and enlarging the pier foundations, connecting them together with traditional rebar and post-tensioned bolts. The foundation block was also rebuilt to remove cracks and restore strength.
